# Technical News

## Tightening torque for air supply (Mercedes Benz) 4185 N P21 / 4390 N P21 / 4758 N P21 / 4757 N P01 / etc.

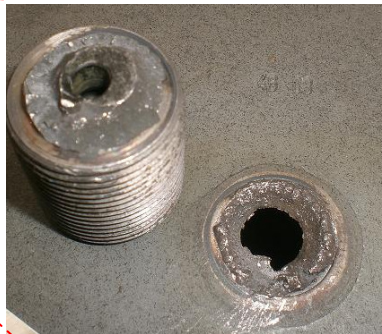
Figure (a)

Unlike many other air springs, these Mercedes types are fastened at the top only by the combi-air supply fitting shown in the figure. This connection has been designed to match the loads associated with the fitting.

In the past year, increased numbers of air spring systems have been sent back with the fitting having torn off. The fault occurs at the point marked (a).

The failure pattern is similar on nearly all the air spring systems which have been inspected. A detailed view is given in Figure (b).

The conical top plate on the returned air spring systems meets the specifications of the vehicle manufacturer. Load tests regularly performed on the threaded fitting as part of our quality assurance measures significantly exceed the given maximum value.

- (1) Tightening torque too high
- (2) Oil and/or grease applied to thread

The failure pattern described is not caused by a production or material failure!

Maximum permissible tightening torque for the air supply fitting according to manufacturer specification: **100 Nm\***. \*("Dry state" = Use of lubricants must be avoided, as these reduce friction, thus causing the threaded fitting to be overloaded when the recommended tightening torque is used.)

It is strictly recommended to use suitable torque wrenches in order to ensure controlled assembly.
